MID-AMERICA PIPELINE SYSTEM
LIQUEFIED PETROLEUM GAS PIPELINE
RUPTURE AND FIRE
DONNELLSON, IOWA
AUGUST 4, 1978

1. Report No. NTSB-PAR-79-1		2. Government Accession No.		3. Recipient's Catalog No.	
4. Title and Subtitle Pipeline Accident Report -- Mid-America Pipeline System Liquefied Petroleum Gas Pipeline Rupture and Fire, Donnellson, Iowa, August 4, 1978				5. Report Date May 3, 1979

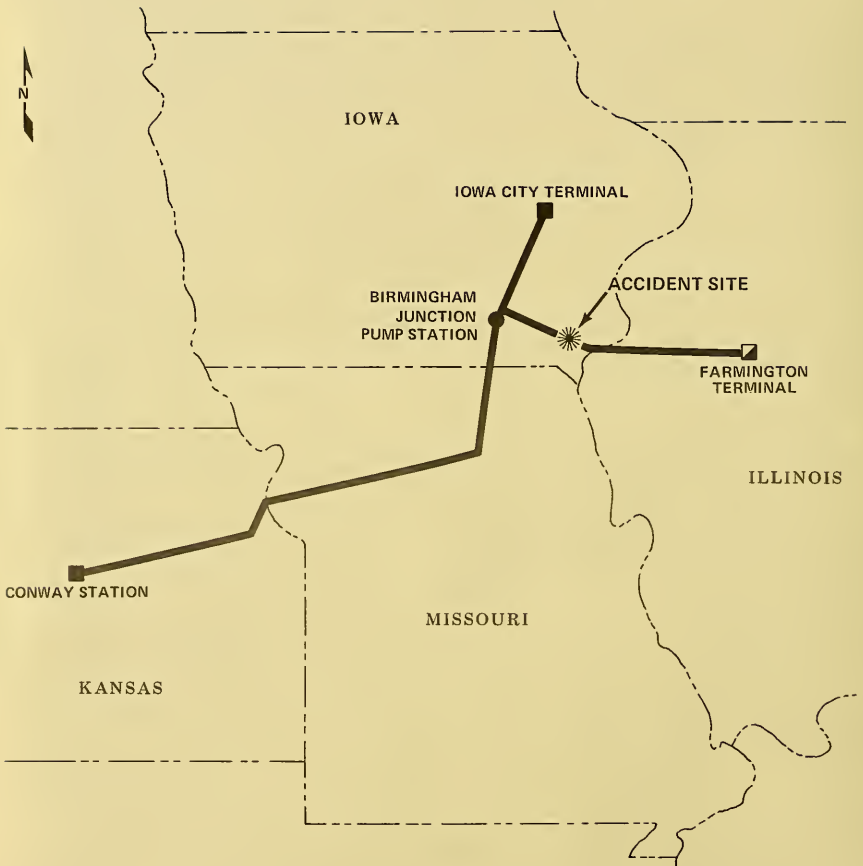
Figure 2. Plan view of pipeline route.

The dispatcher had requested the Iowa City terminal to open a suction pressure control valve there on the main line (see figure 2) sometime between 11 p.m. and midnight. The dispatcher said he thought that the valve might have been opened more than necessary; this would have caused such a pressure drop. Therefore, he did not immediately suspect a leak in the system.

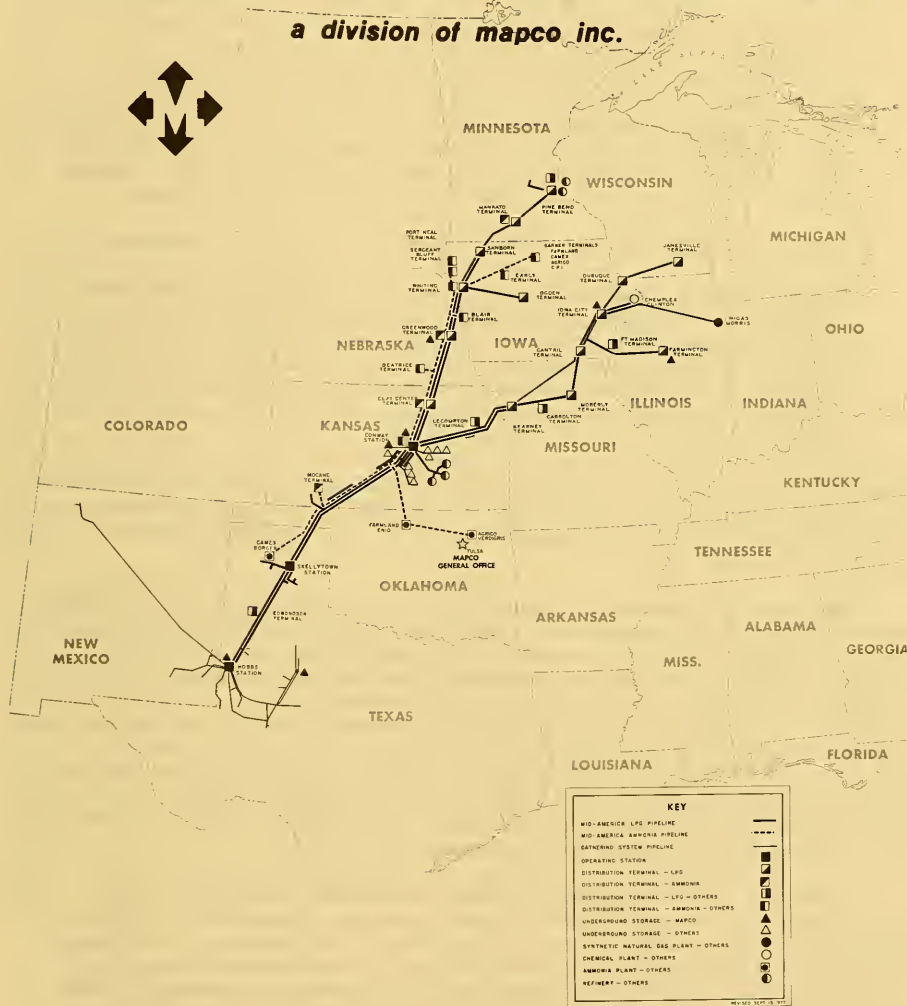
Figure 5. MAPCO pipeline system.

MAPCO, a common carrier LPG pipeline, extends from west Texas to Conway, Kansas, where it forms two branches. One branch extends to Minneapolis, Minnesota and the other extends to Janesville, Wisconsin. The pipeline system contains more than 5,000 miles of multiple lines from 4 inches to 12 inches in diameter which cross the States of New Mexico, Texas, Oklahoma, Kansas, Nebraska, Missouri, Iowa, Illinois, Minnesota, and Wisconsin. MAPCO transports eight liquefiable hydrocarbons. Ethane-propane mix, propane, iso-butane, normal butane, butane mix, natural gasoline, and a demethanized mix. The original system constructed in 1960 consisted of 2,200 miles of pipelines. Additional lines were added in 1961, 1967, 1968, 1969, and later. (See figure 5.)

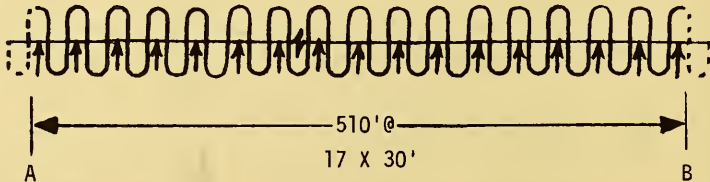
Figure 1.

e. Stress due to earth fill

Now it is possible that this earth loading tried to lift the pipe to the left of A (Point A shown in Figure 1)
